NASA TN D-1376

INFLUENCE OF TIRE TREAD PATTERN AND RUNWAY SURFACE  
CONDITION ON BRAKING FRICTION AND ROLLING  
RESISTANCE OF A MODERN AIRCRAFT TIRE

By Walter B. Horne and Trafford J. W. Leland

Langley Research Center  
Langley Station, Hampton, Va.

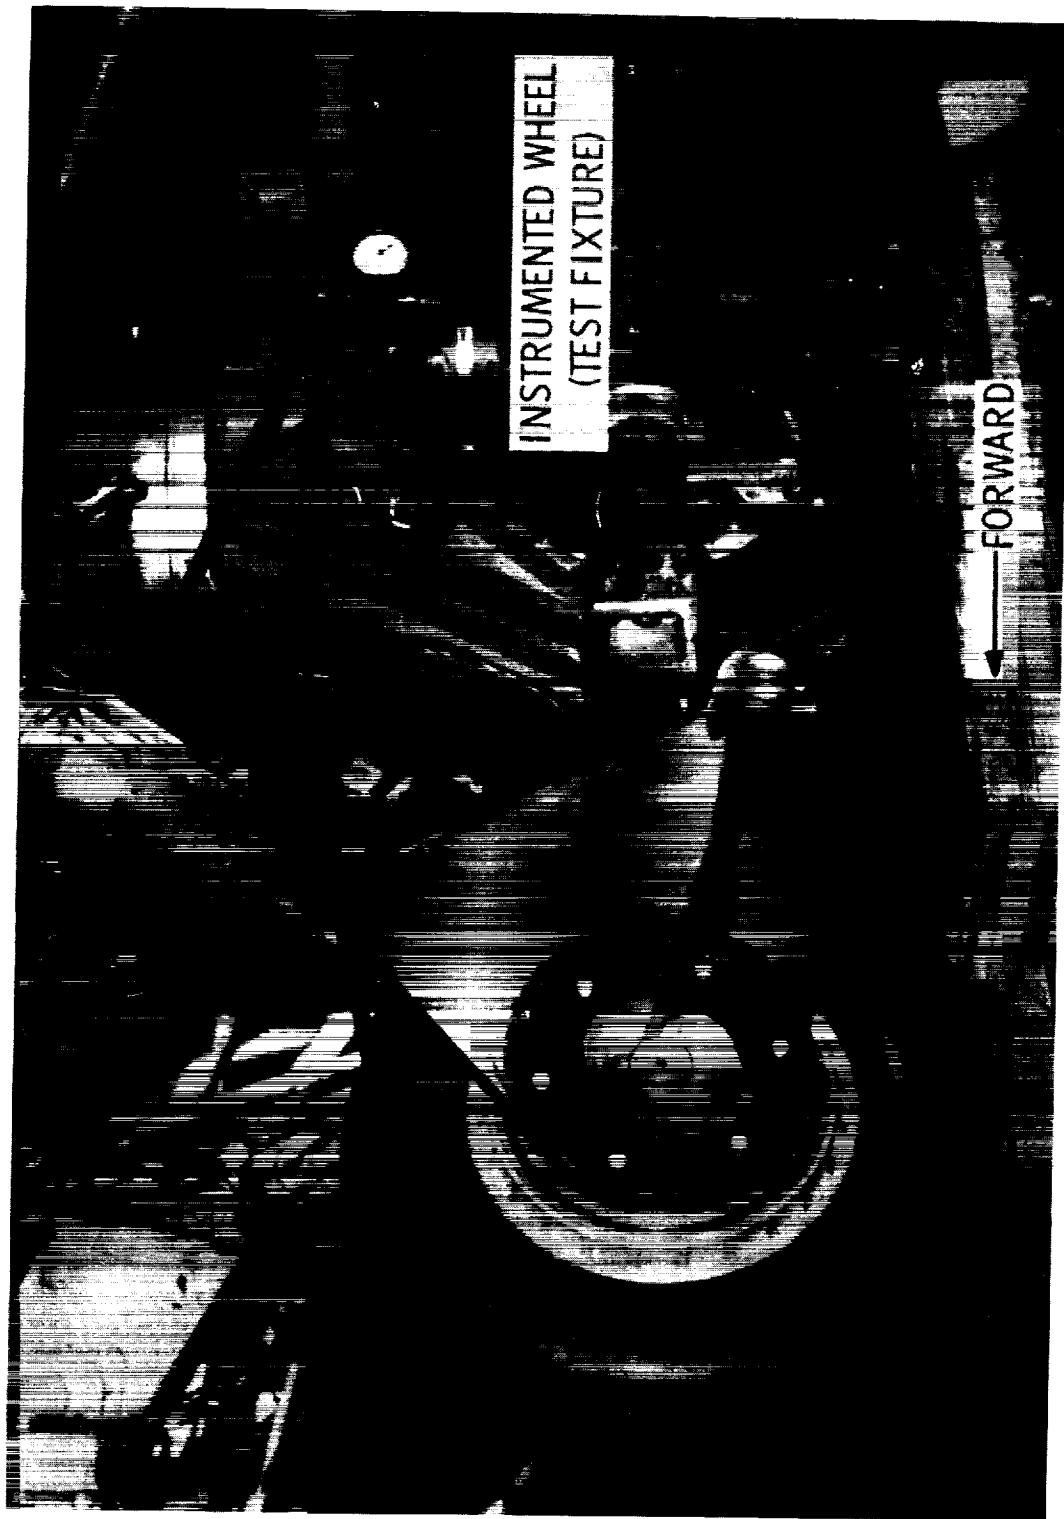
Figure 3.- Tandem wheel setup at Langley landing-loads track. I-60-6948

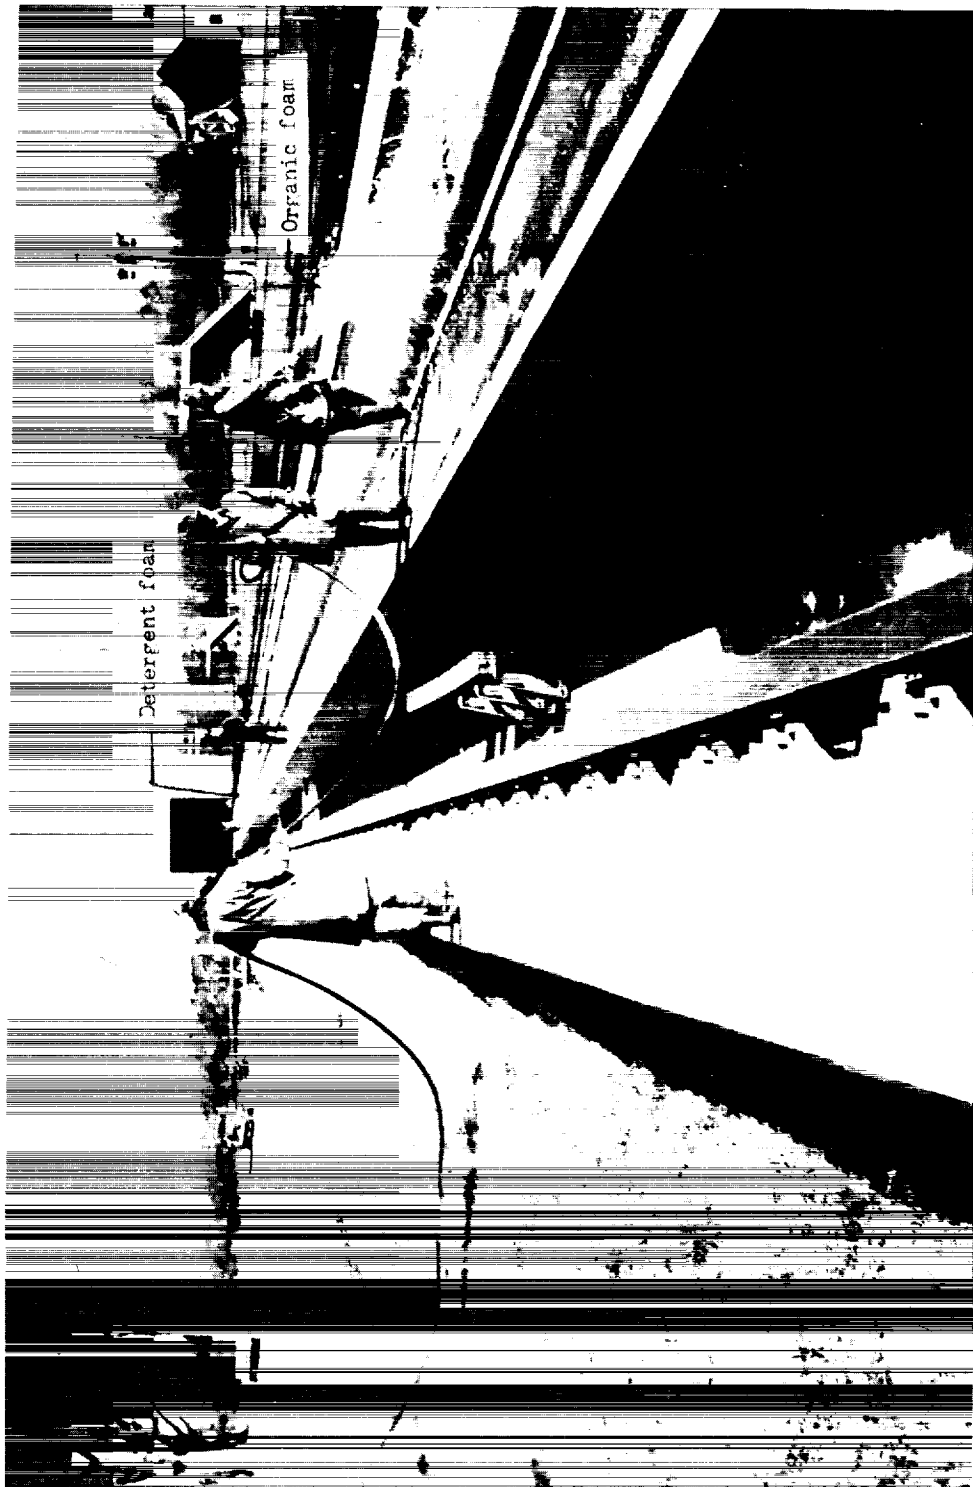
L-62-2077  
Figure 10.- Spreading detergent and organic foam on concrete runway just before start of a  
braked rolling run.

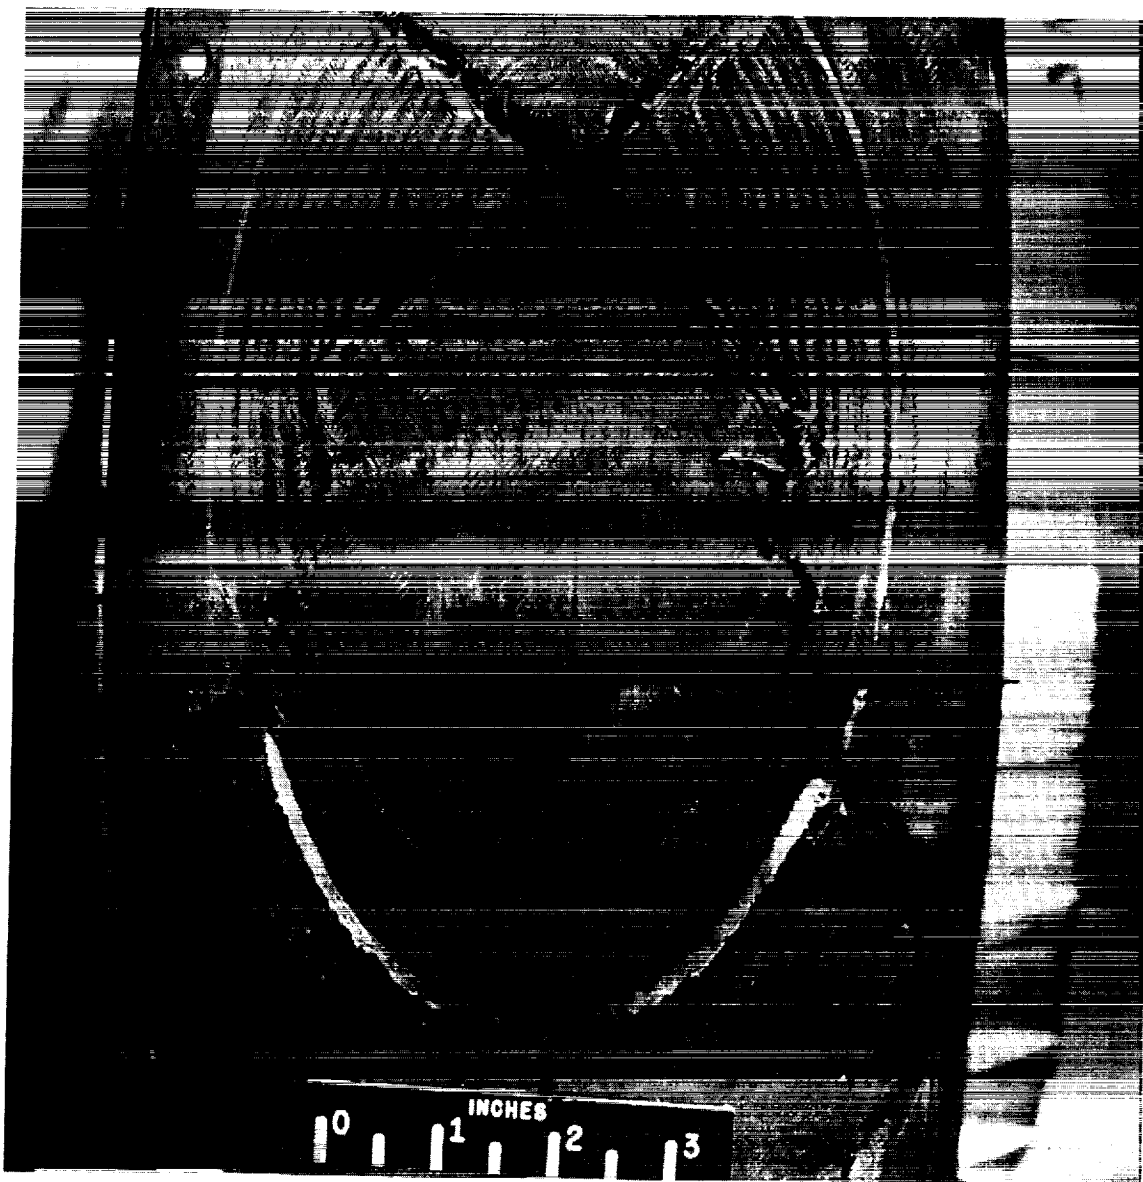
L-62-2078

Figure 22.- Tire appearance after skidding approximately 60 feet on a dry concrete runway.
